# Foot Screening Mapping Examples

## Foot Screening Mapping Examples Touch-Test™ Sensory Evaluators

North Coast Medical, Inc.  
18305 Sutter Boulevard  
Morgan Hill, CA 95037-2845  
800 821-9319  
www.touch-test.com

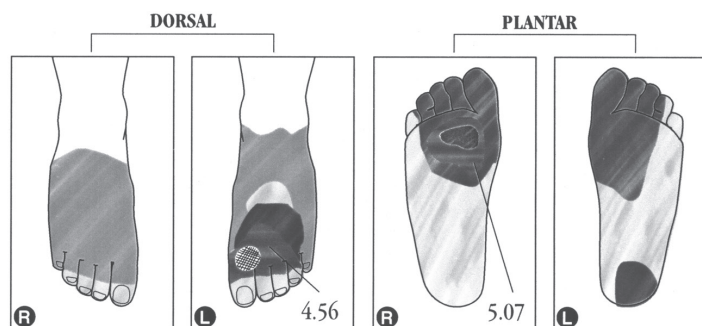
### Initial Evaluation - Visit #1

RIGHT FOOT: Superficial ulcer on plantar surface over the second metatarsal head.

LEFT FOOT: Pre-ulcer proximal to the first dorsal web space.

Patient education, treatment intervention and wound care management initiated.

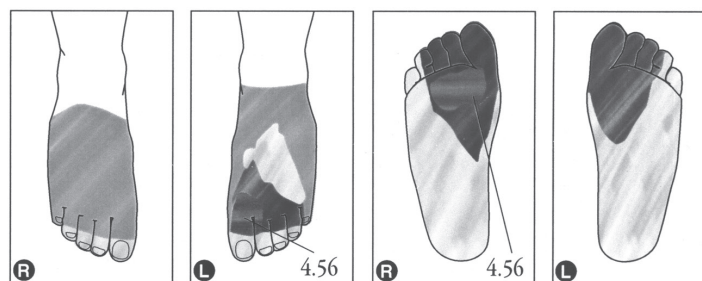
### Re-evaluation - Visit #2

RIGHT FOOT: Ulcer healed. Improved to diminished protective sensation on plantar surface over the second metatarsal head.

LEFT FOOT: Pre-ulcer healed. Loss of protective sensation proximal to the first dorsal web space.

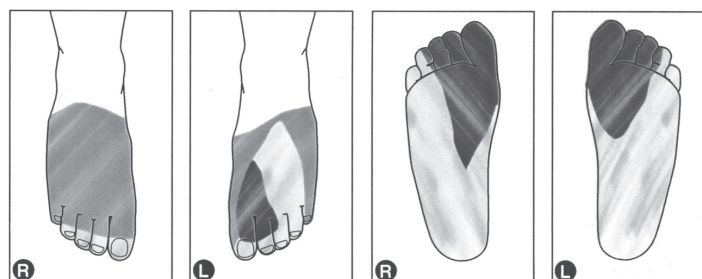
### Re-evaluation - Visit #3

BOTH FEET: Diminished light touch sensation at toes and plantar surfaces.

LEFT FOOT: Improved to diminished protective sensation proximal to the first dorsal web space.

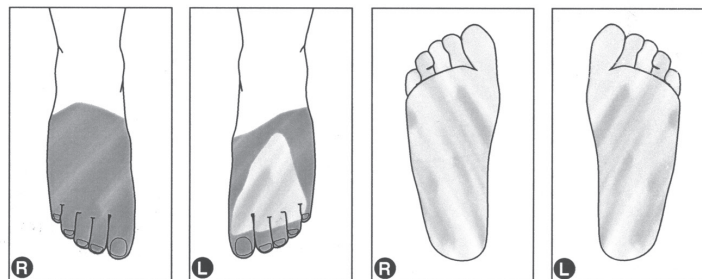
### Re-evaluation - Visit #4

RIGHT FOOT: Normal throughout.

LEFT FOOT: Improved to diminished light touch sensation over dorsal web spaces.
